Australian Transport Safety Bureau

Total power loss involving a Bell 47G2A, VH-KHJ

near Amberley Airport, Queensland, 23 July 2013

ATSB Transport Safety Report
Aviation Occurrence Investigation
AO-2013-119
Final – 31 October 2013

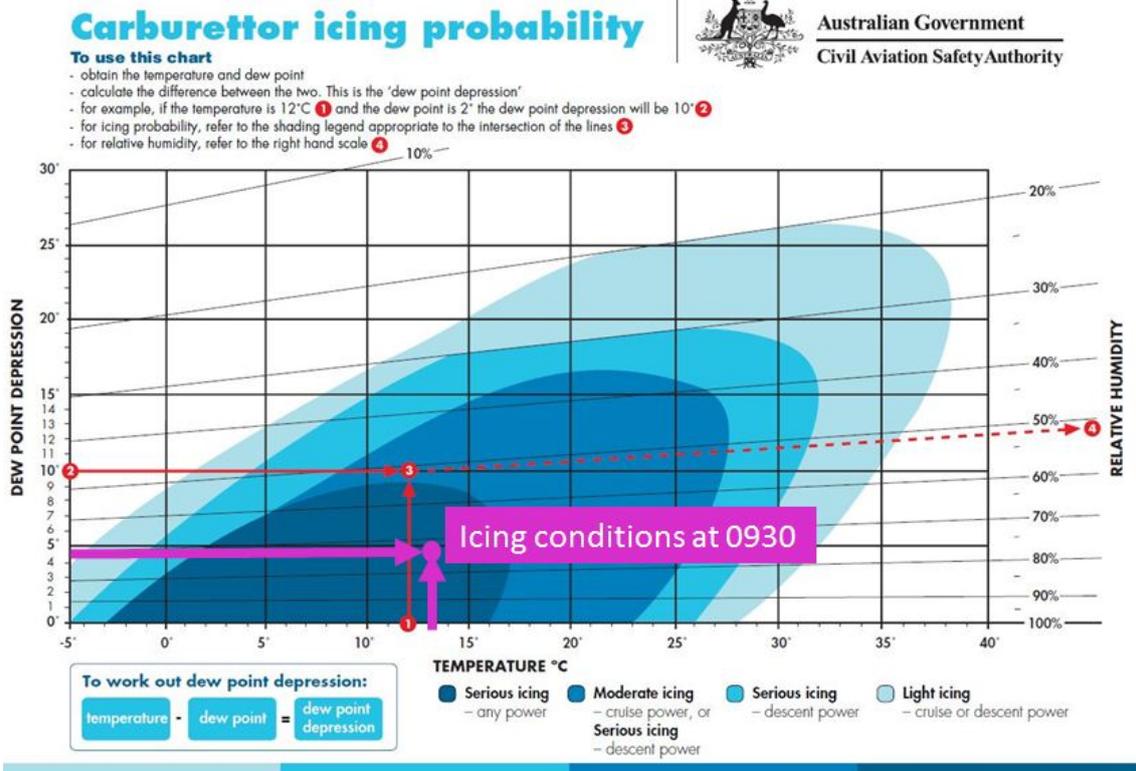
Figure 1: Carburettor icing probability

Weather observations from the Bureau of Meteorology's automatic weather station at Amberley indicated that at 0930, the temperature was 13.5° C and the dew point⁶ was 9.1° C. The dew point depression was calculated by subtracting the dew point from the temperature, and at that time was 4.4.

According to the Carburettor Icing Probability chart (Figure 1), the conditions indicated a serious probability of carburettor icing at any power.

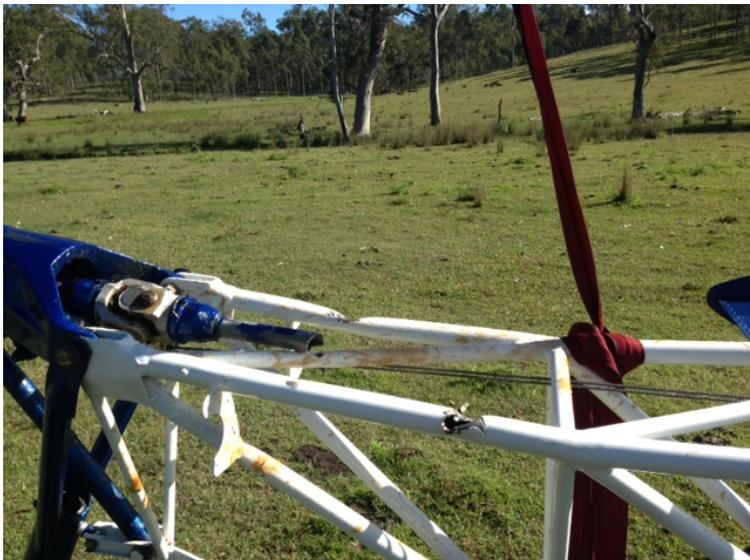
Figure 2: Damage to VH-KHJ

The pilot immediately lowered the collective² and established the helicopter in an autorotation.³ He selected an appropriate landing area and broadcast a Mayday⁴ call. Just before reaching the ground, the pilot flared⁵ the helicopter for landing. Within 40 seconds of the engine failure, the helicopter landed heavily and was substantially damaged. Neither the pilot nor the photographer was injured.

When the insurance assessor arrived on site, the helicopter engine was started and performed without fault. No fuel contamination was found. Other than the damage sustained in the accident, the helicopter was reported to have been well maintained and in excellent condition.

The insurance assessor considered that the weather conditions were an incipient cause of the incident. At the time, the temperature and dew point indicated a risk of serious carburettor icing. The pilot reported that he would have expected the engine to run roughly if carburettor icing was present.

All pilots of aircraft fitted with a carburettor are advised to check the forecast conditions and know the risk of carburettor icing prior to each flight. The carburettor icing probability chart is available at
